Removal of malpositioned implant fixture on post.Maxilla

Dr.root
Well dental clinic

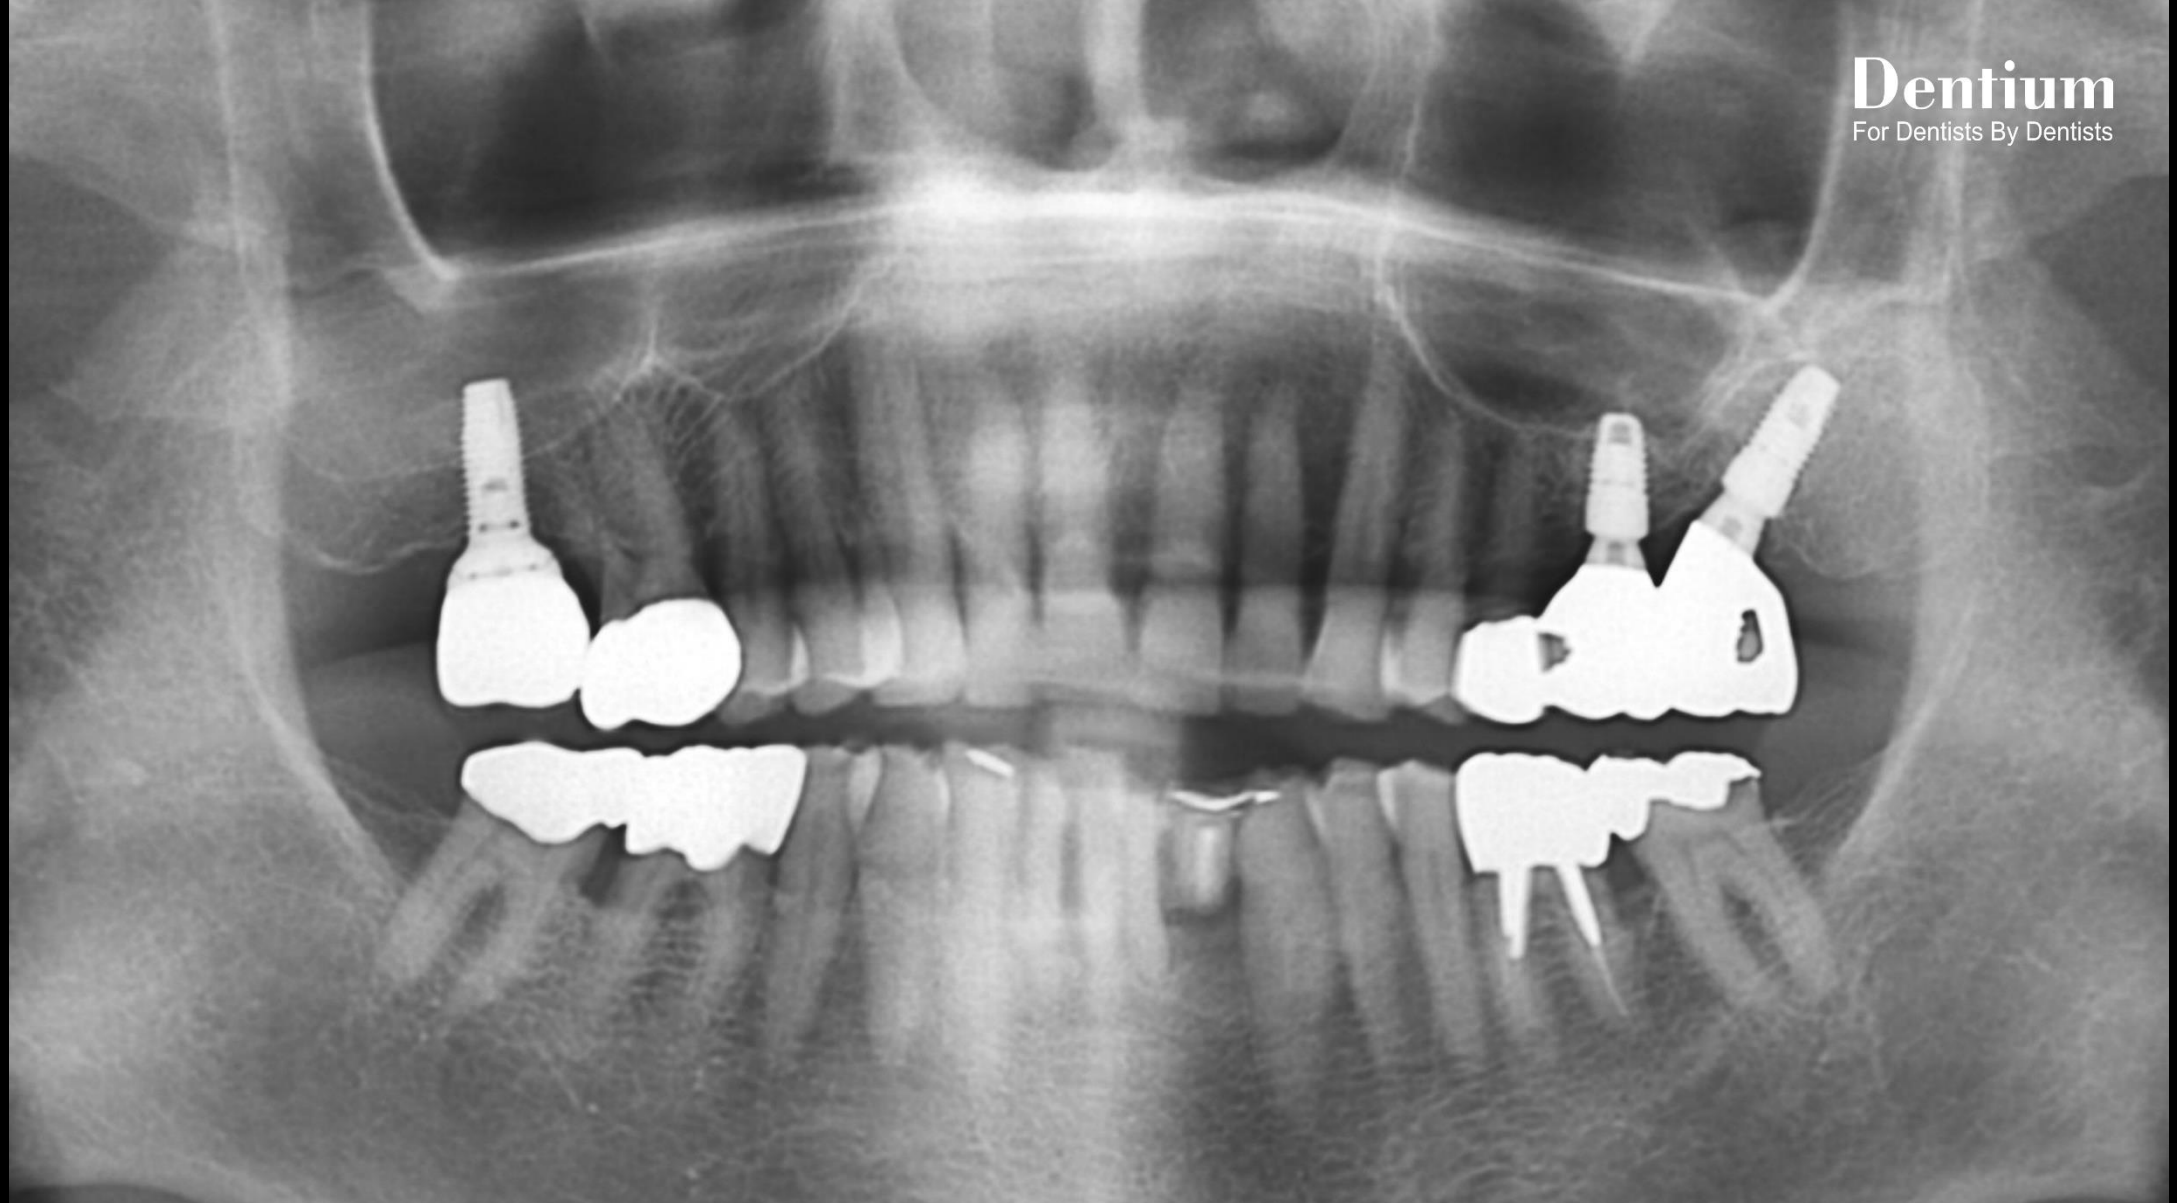
Pre-op

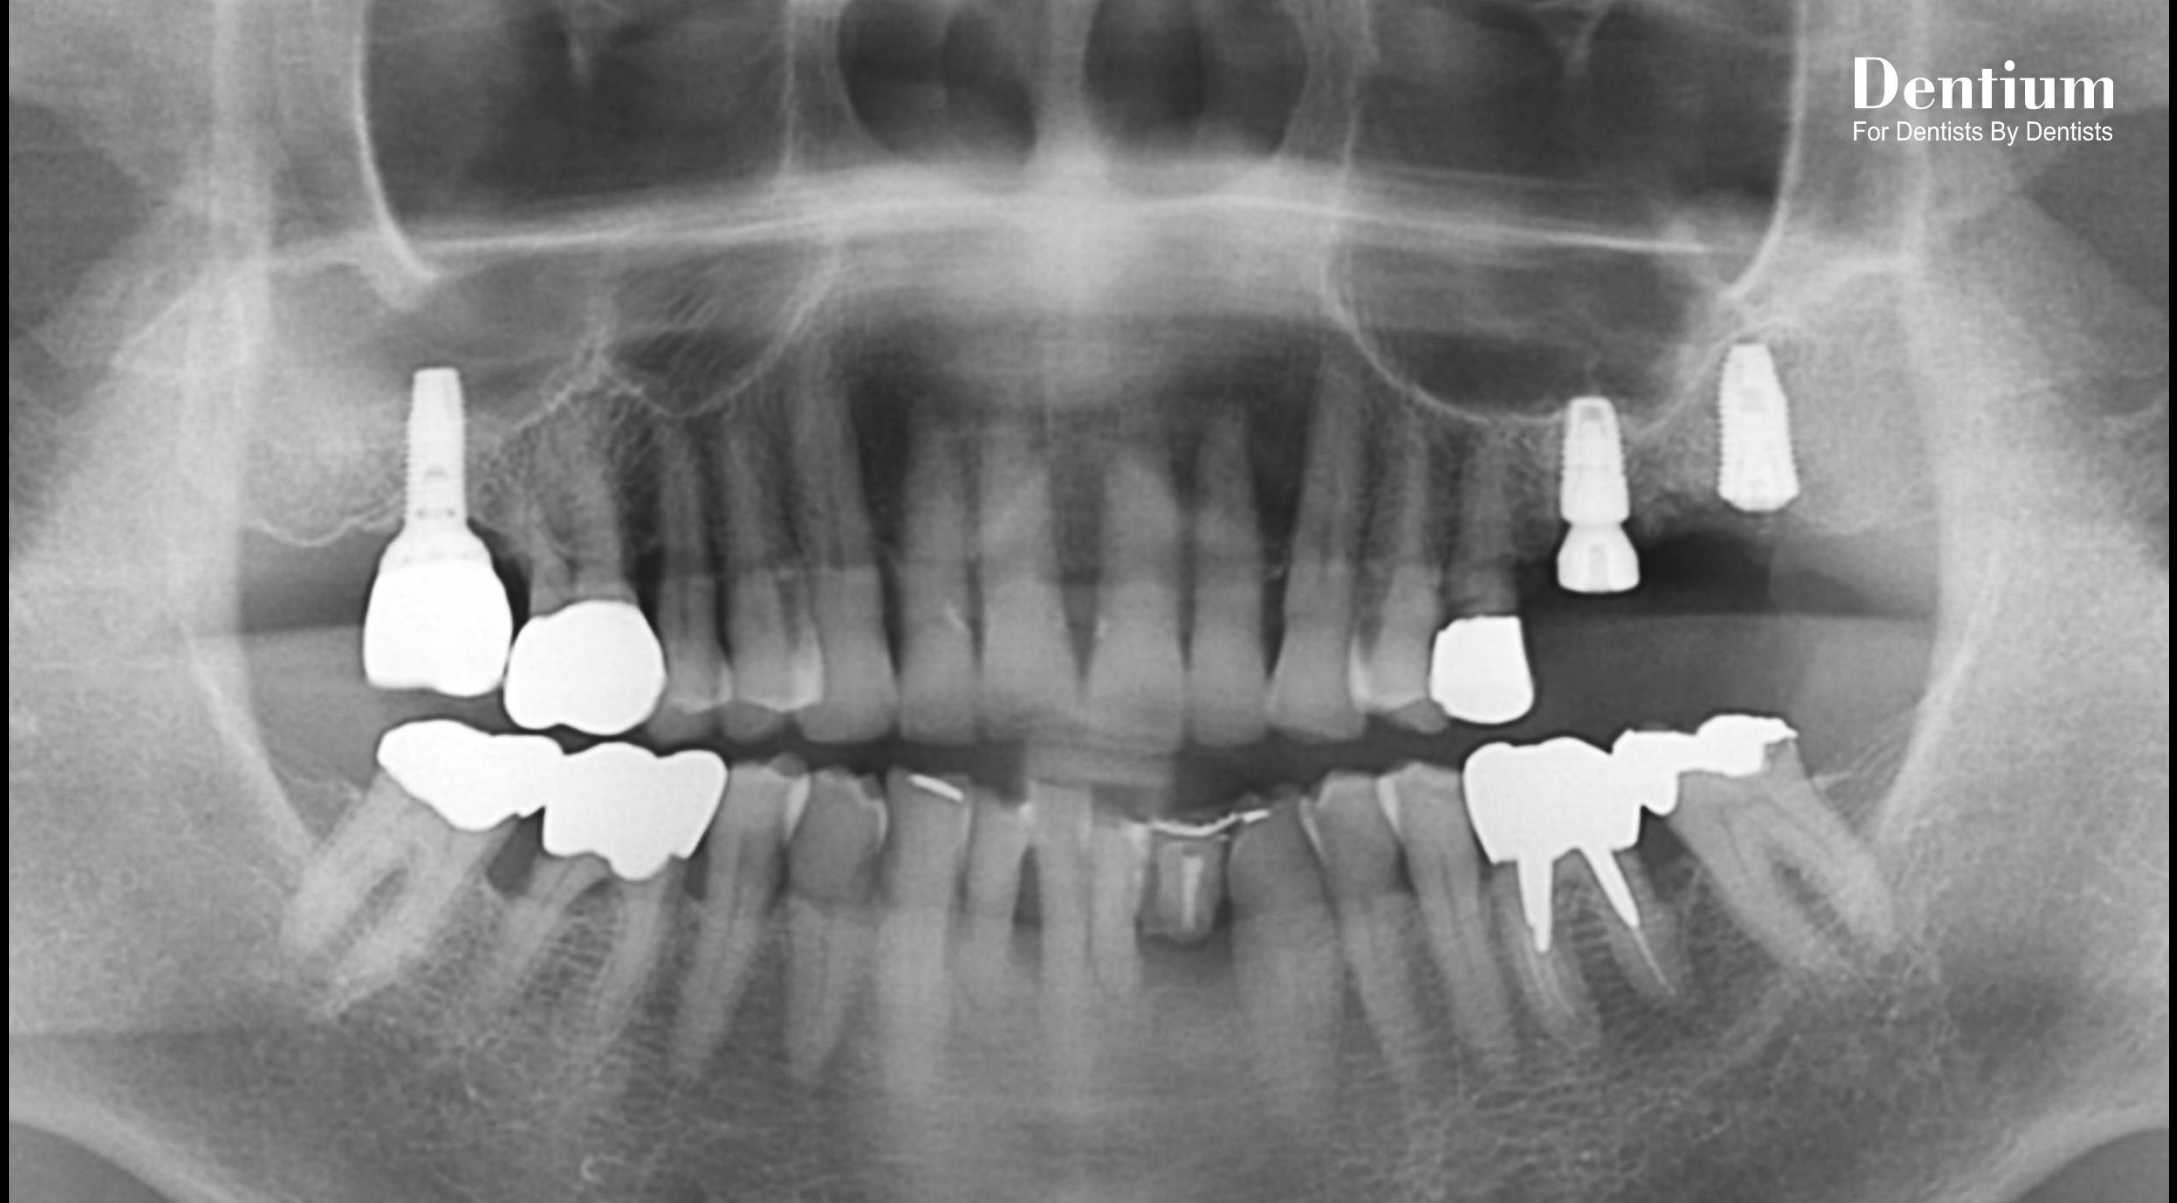
Post-op

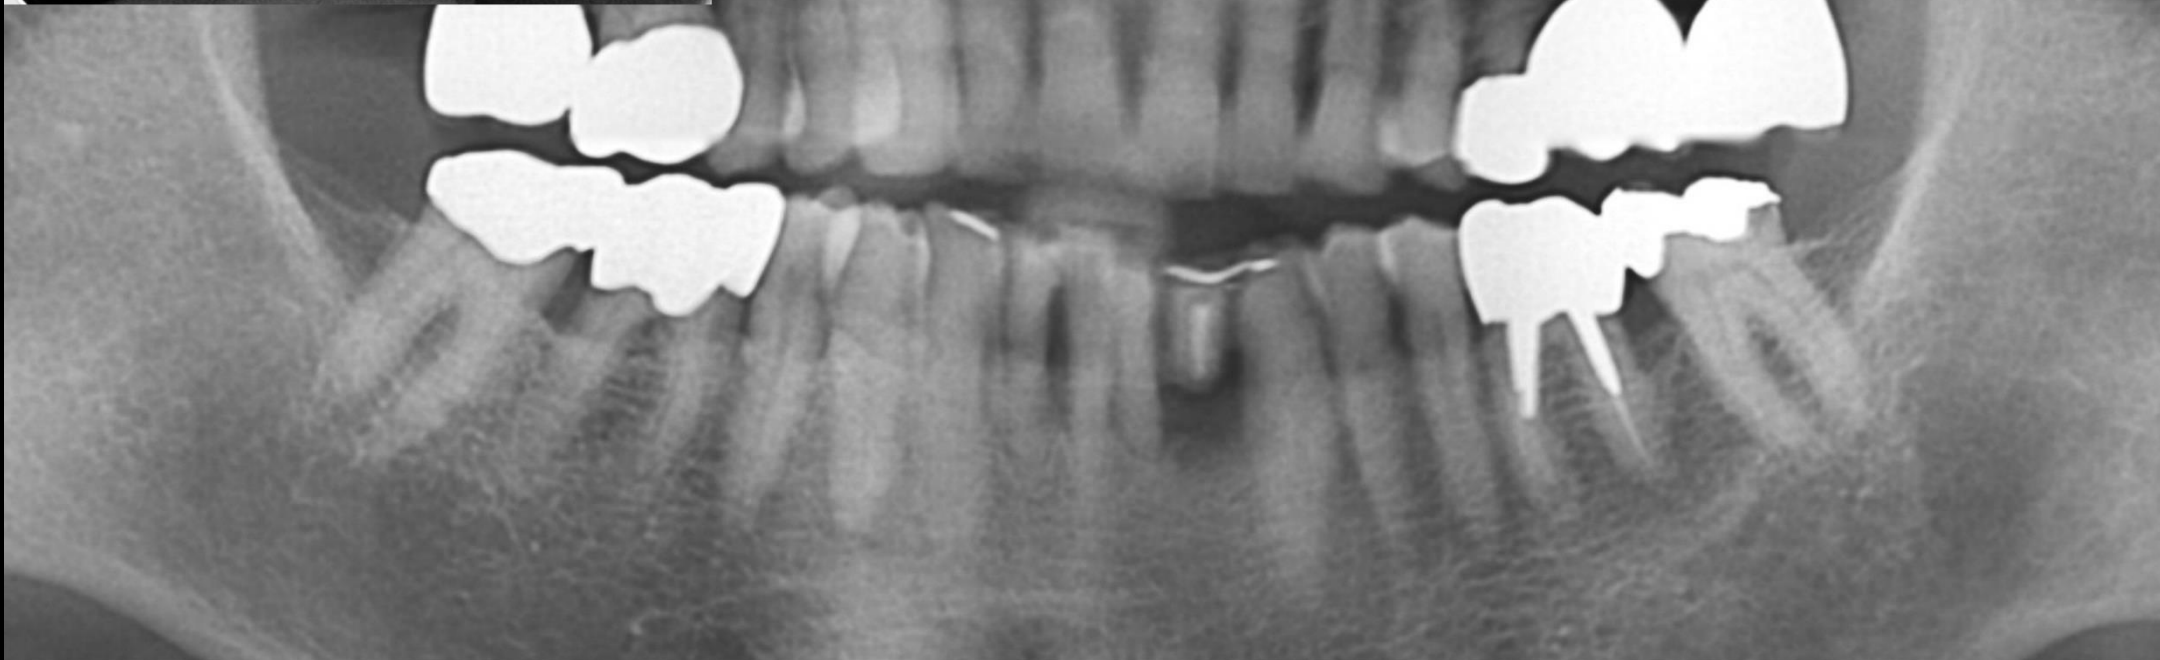
Final prosthesis

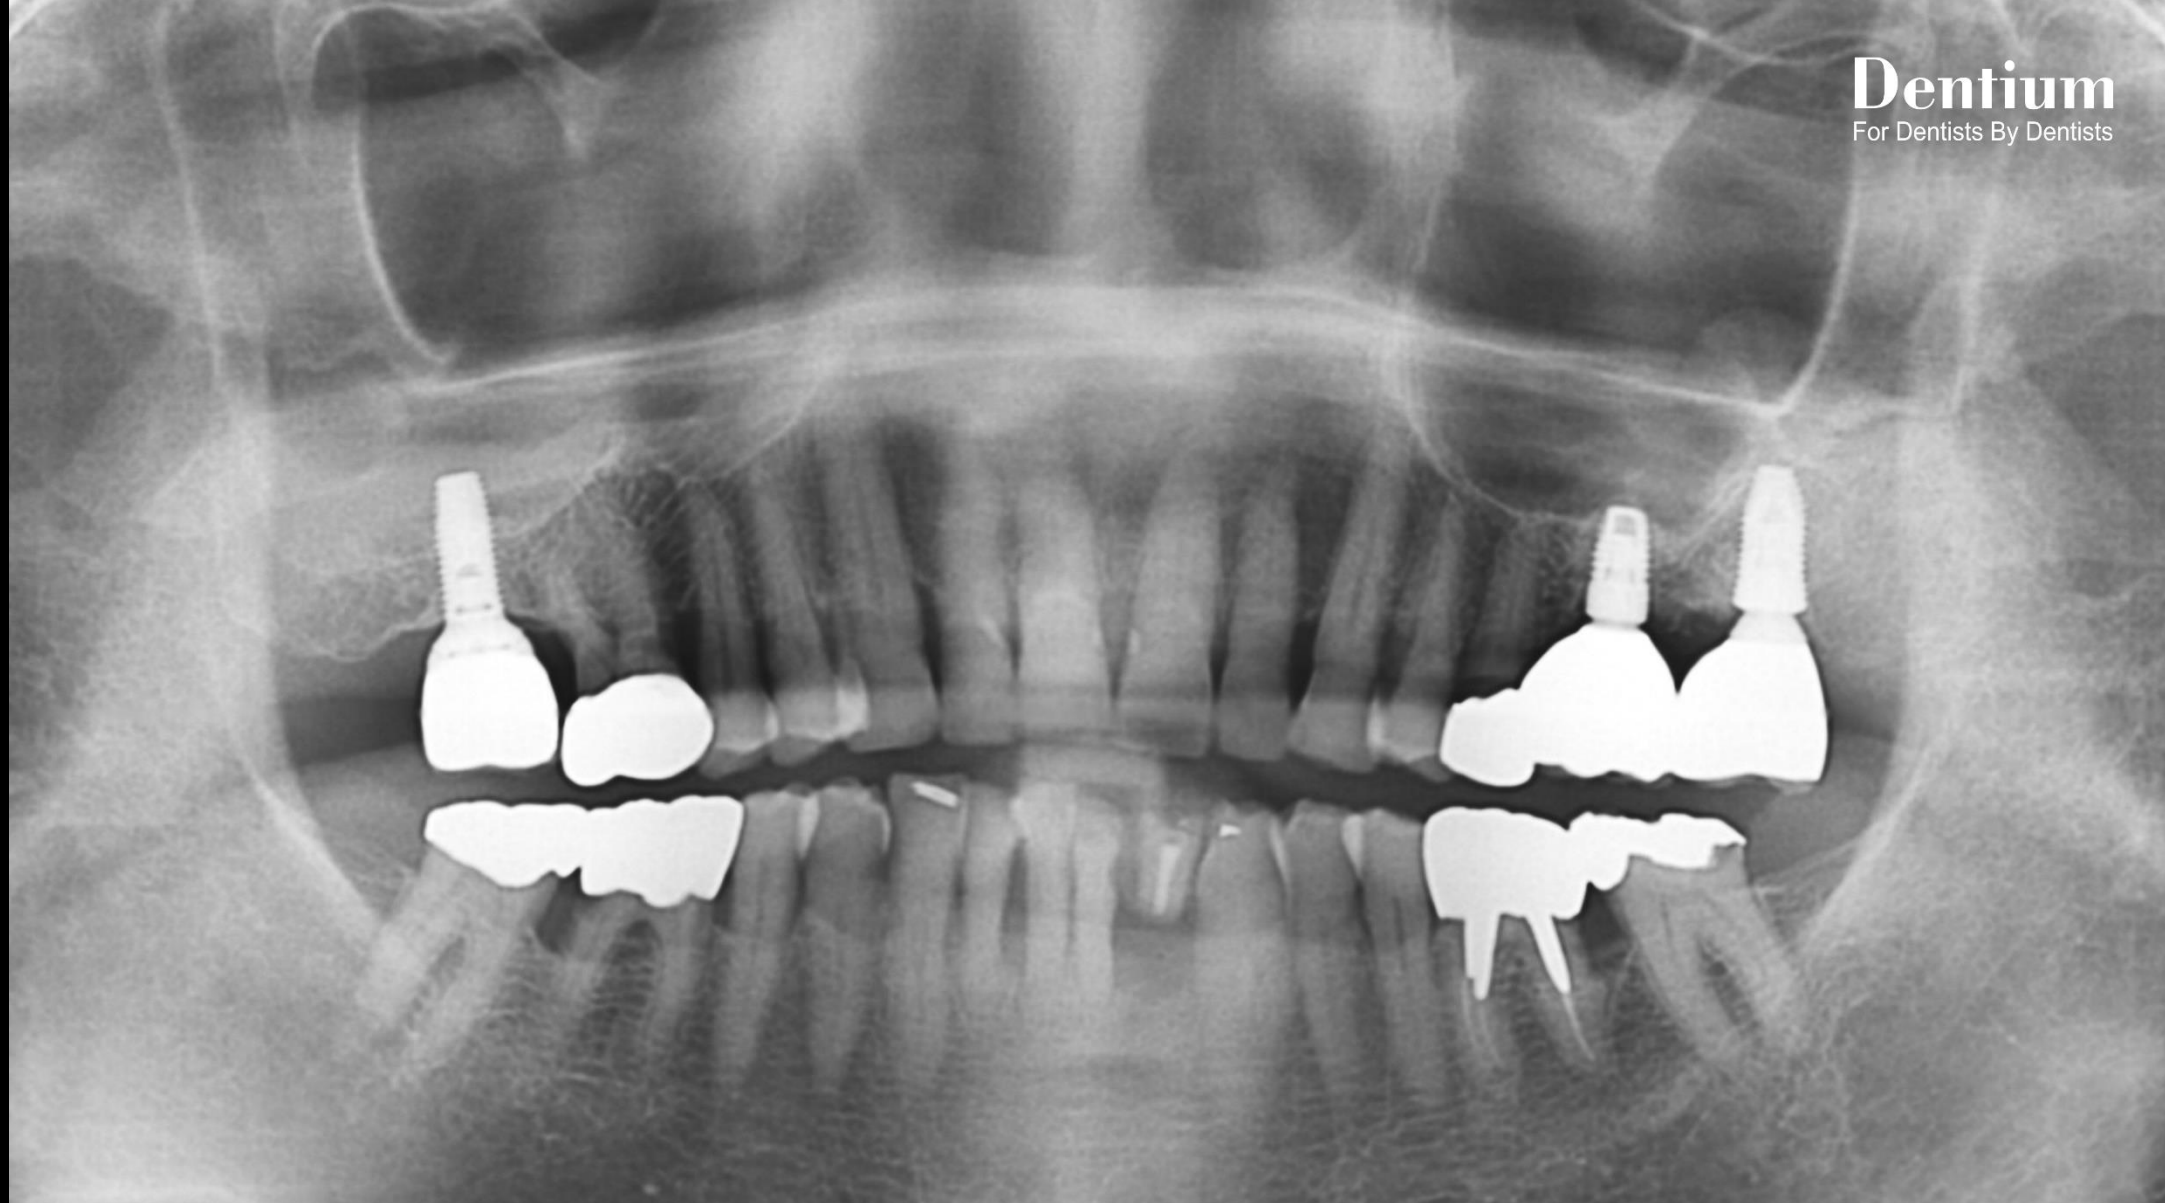
Follow up : 1 year 2 months

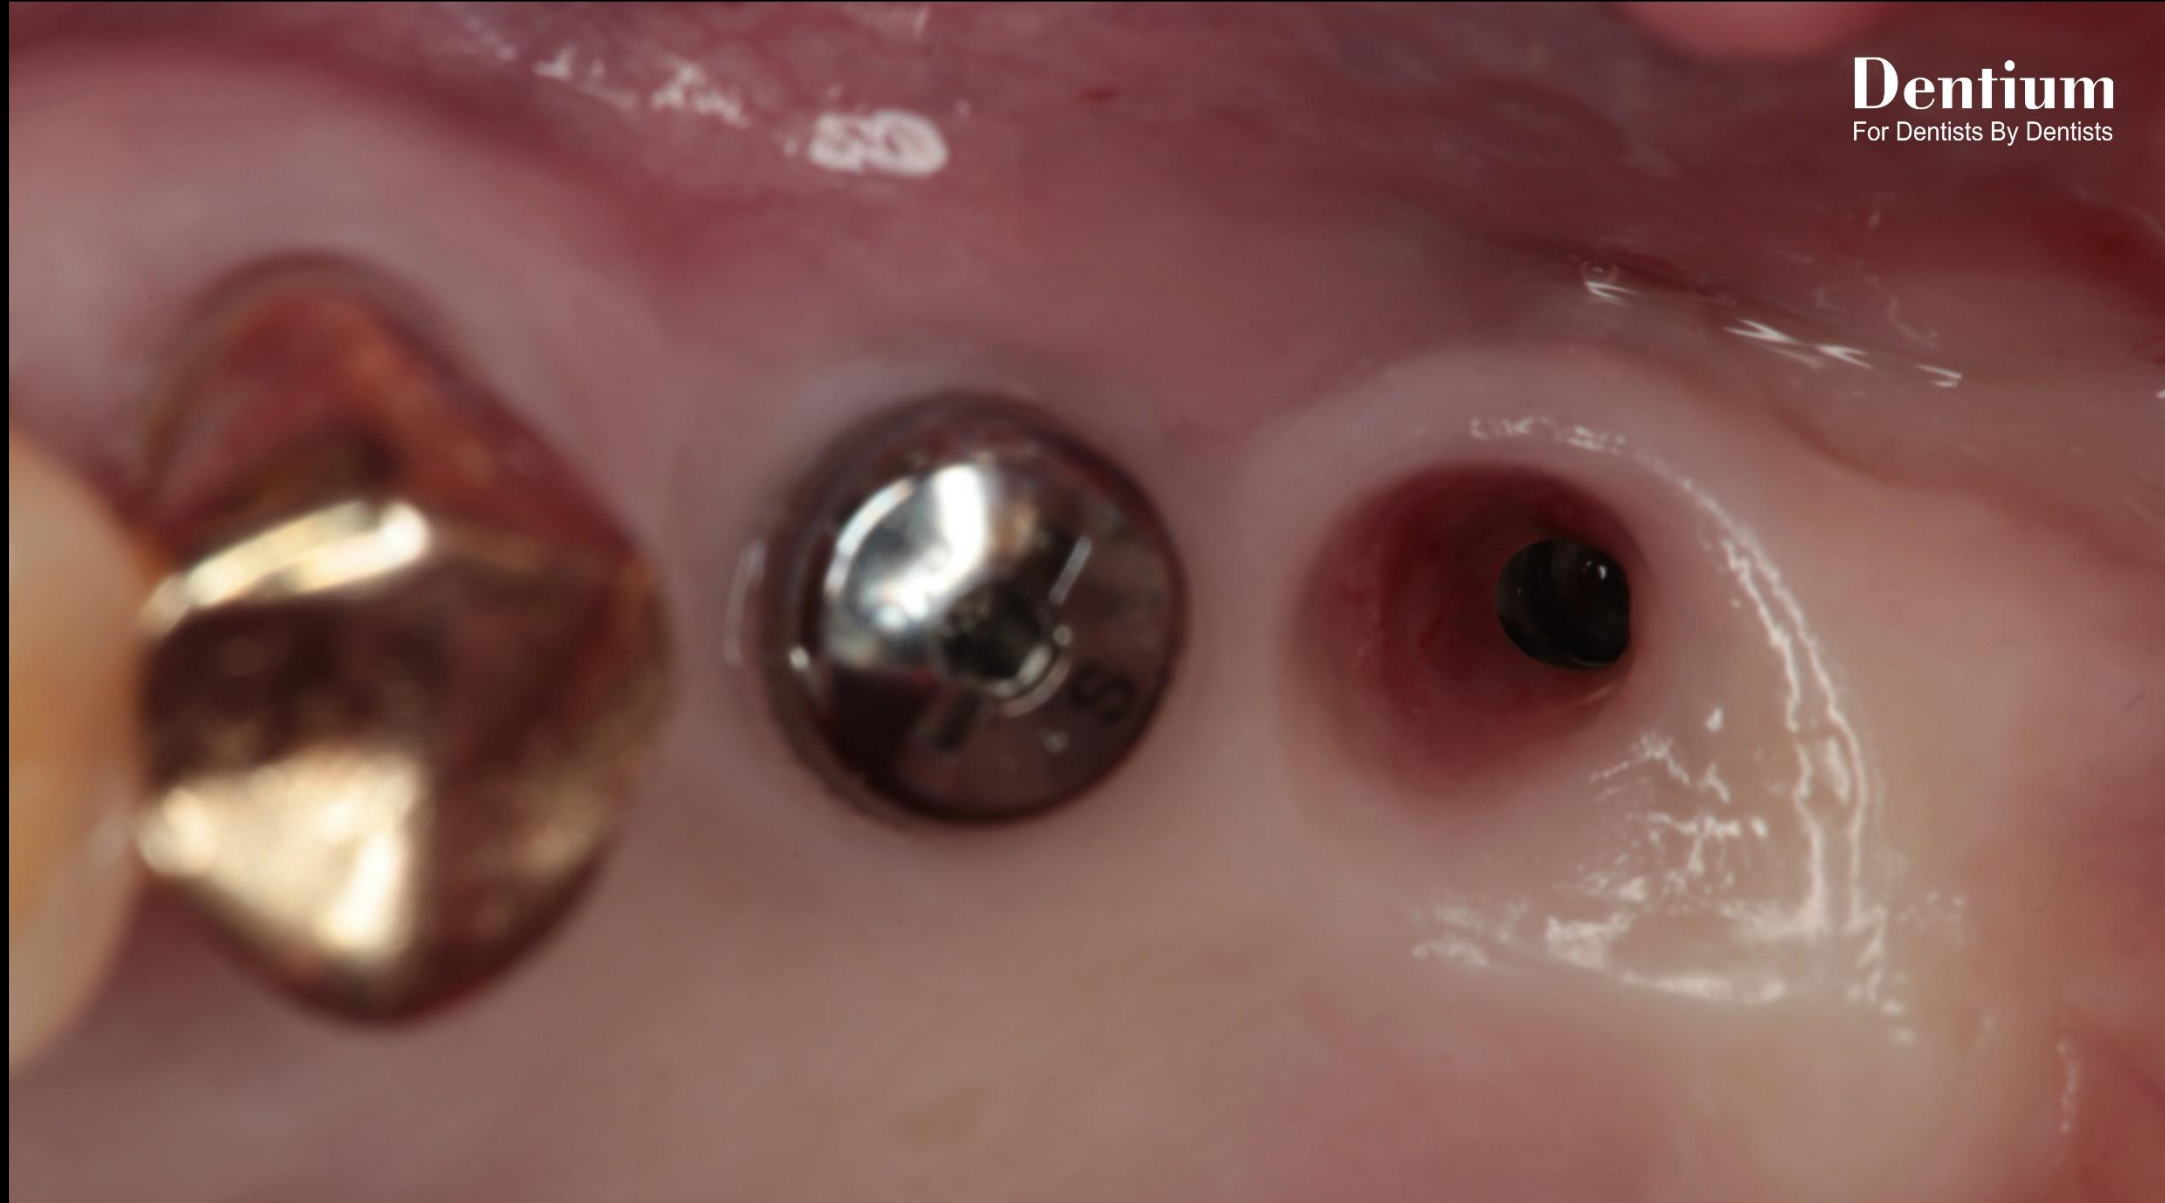
Pre-op

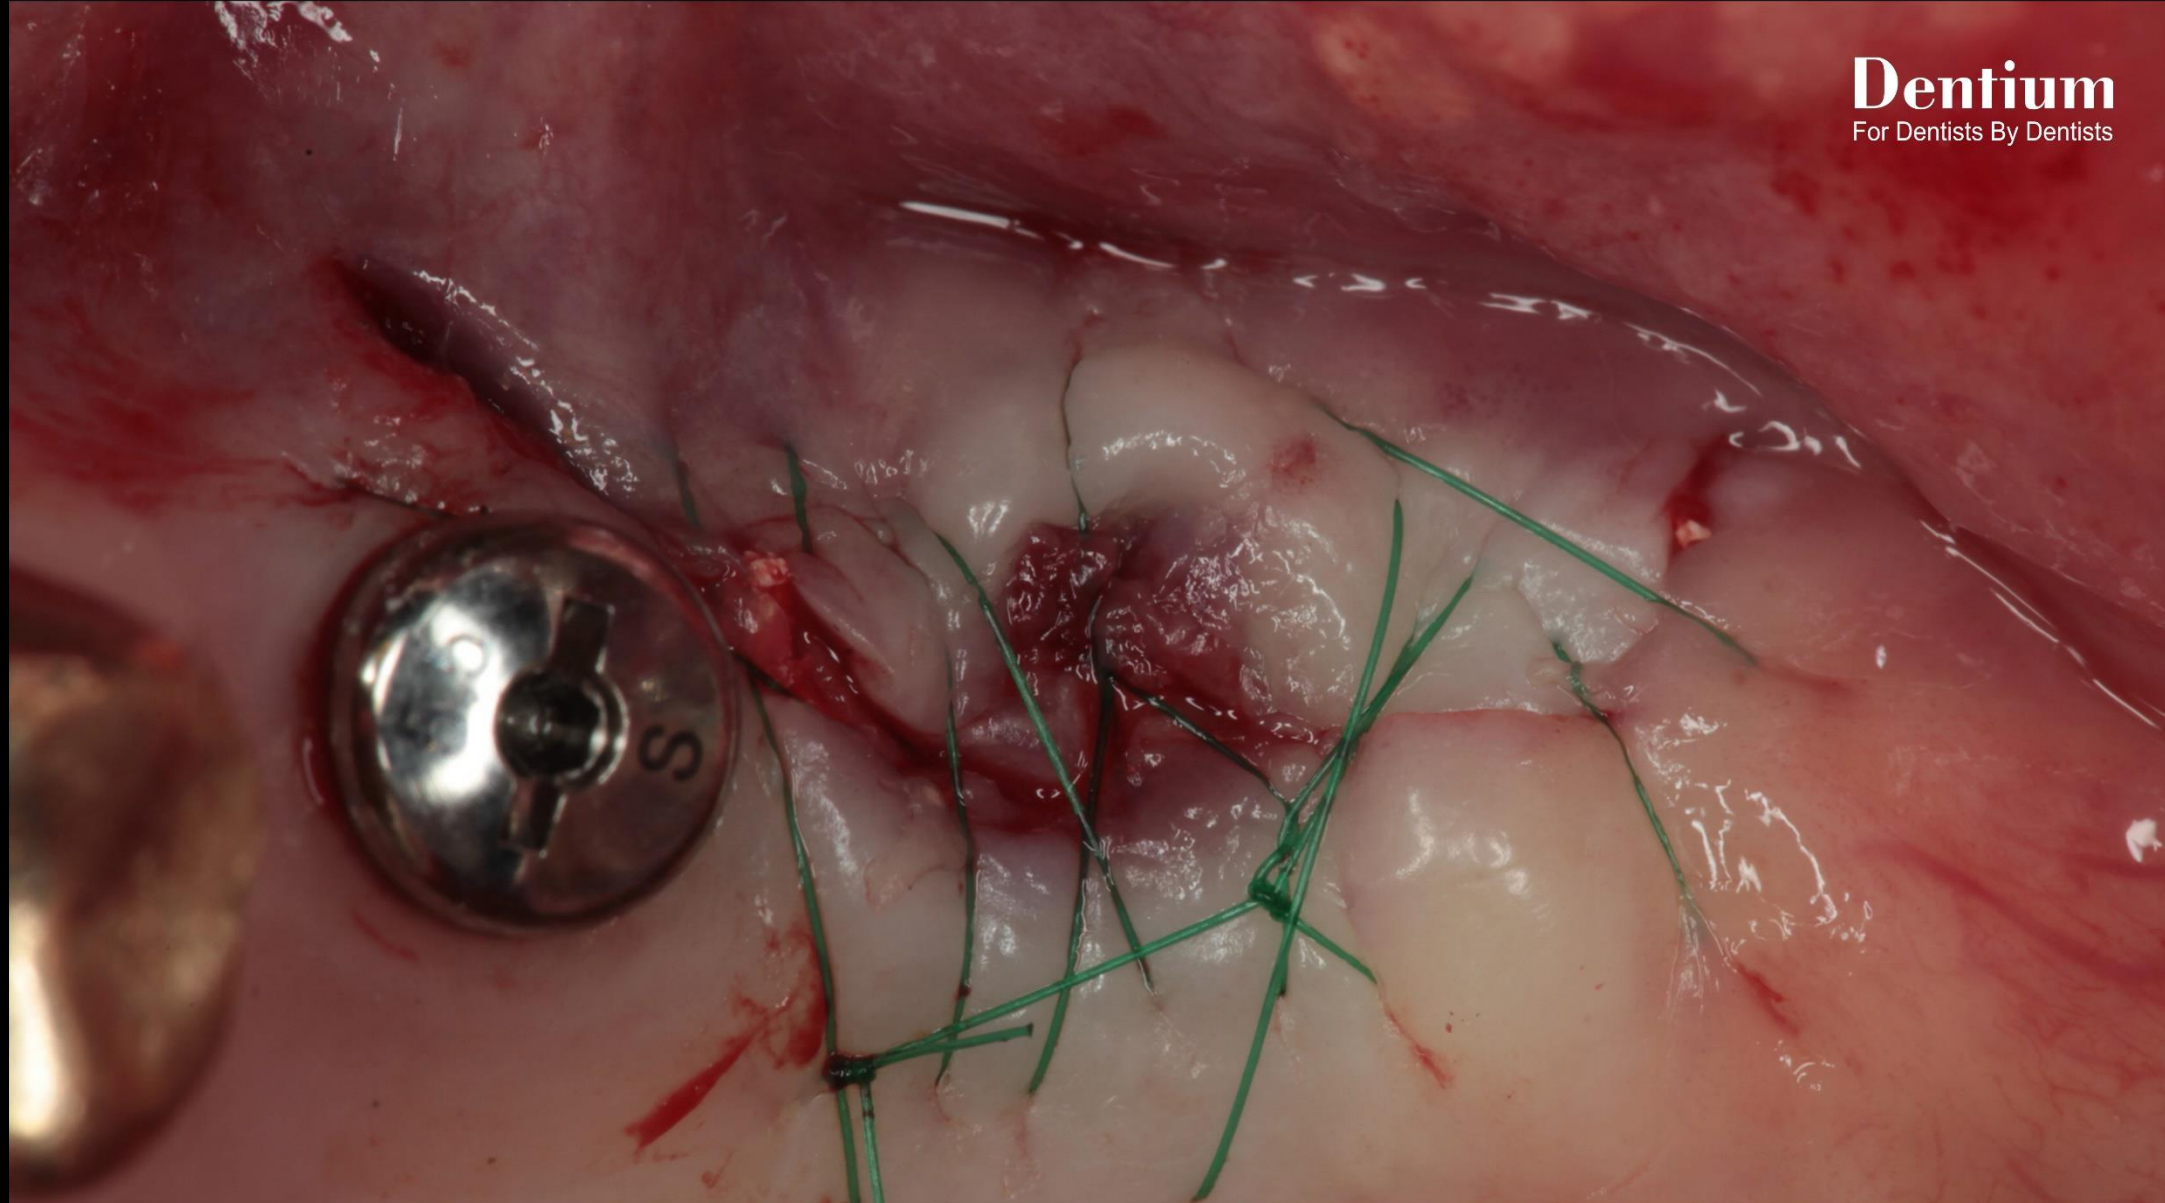
Post-op

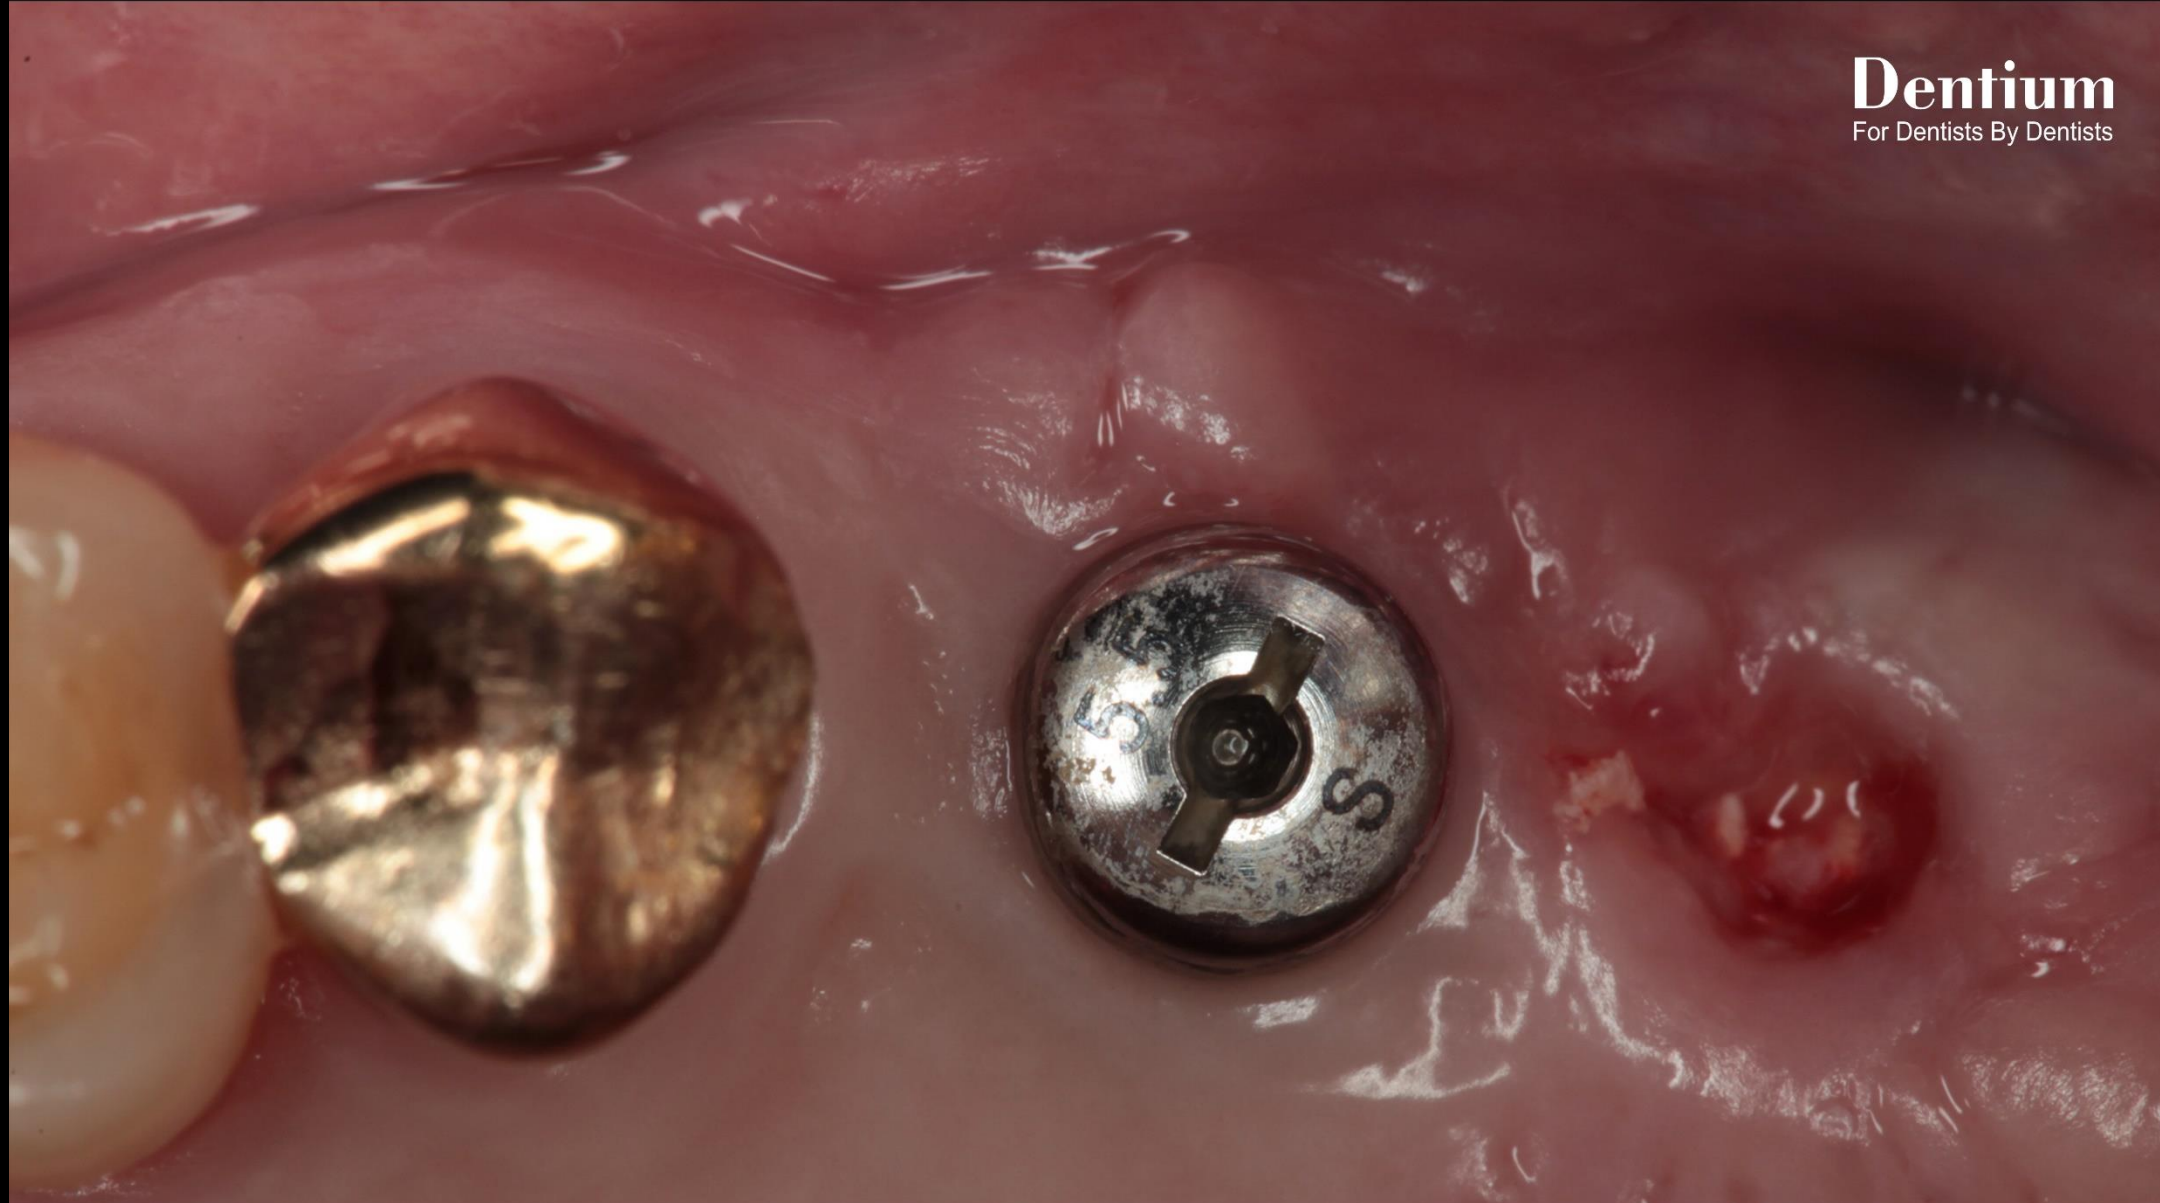
Healing : 2 weeks

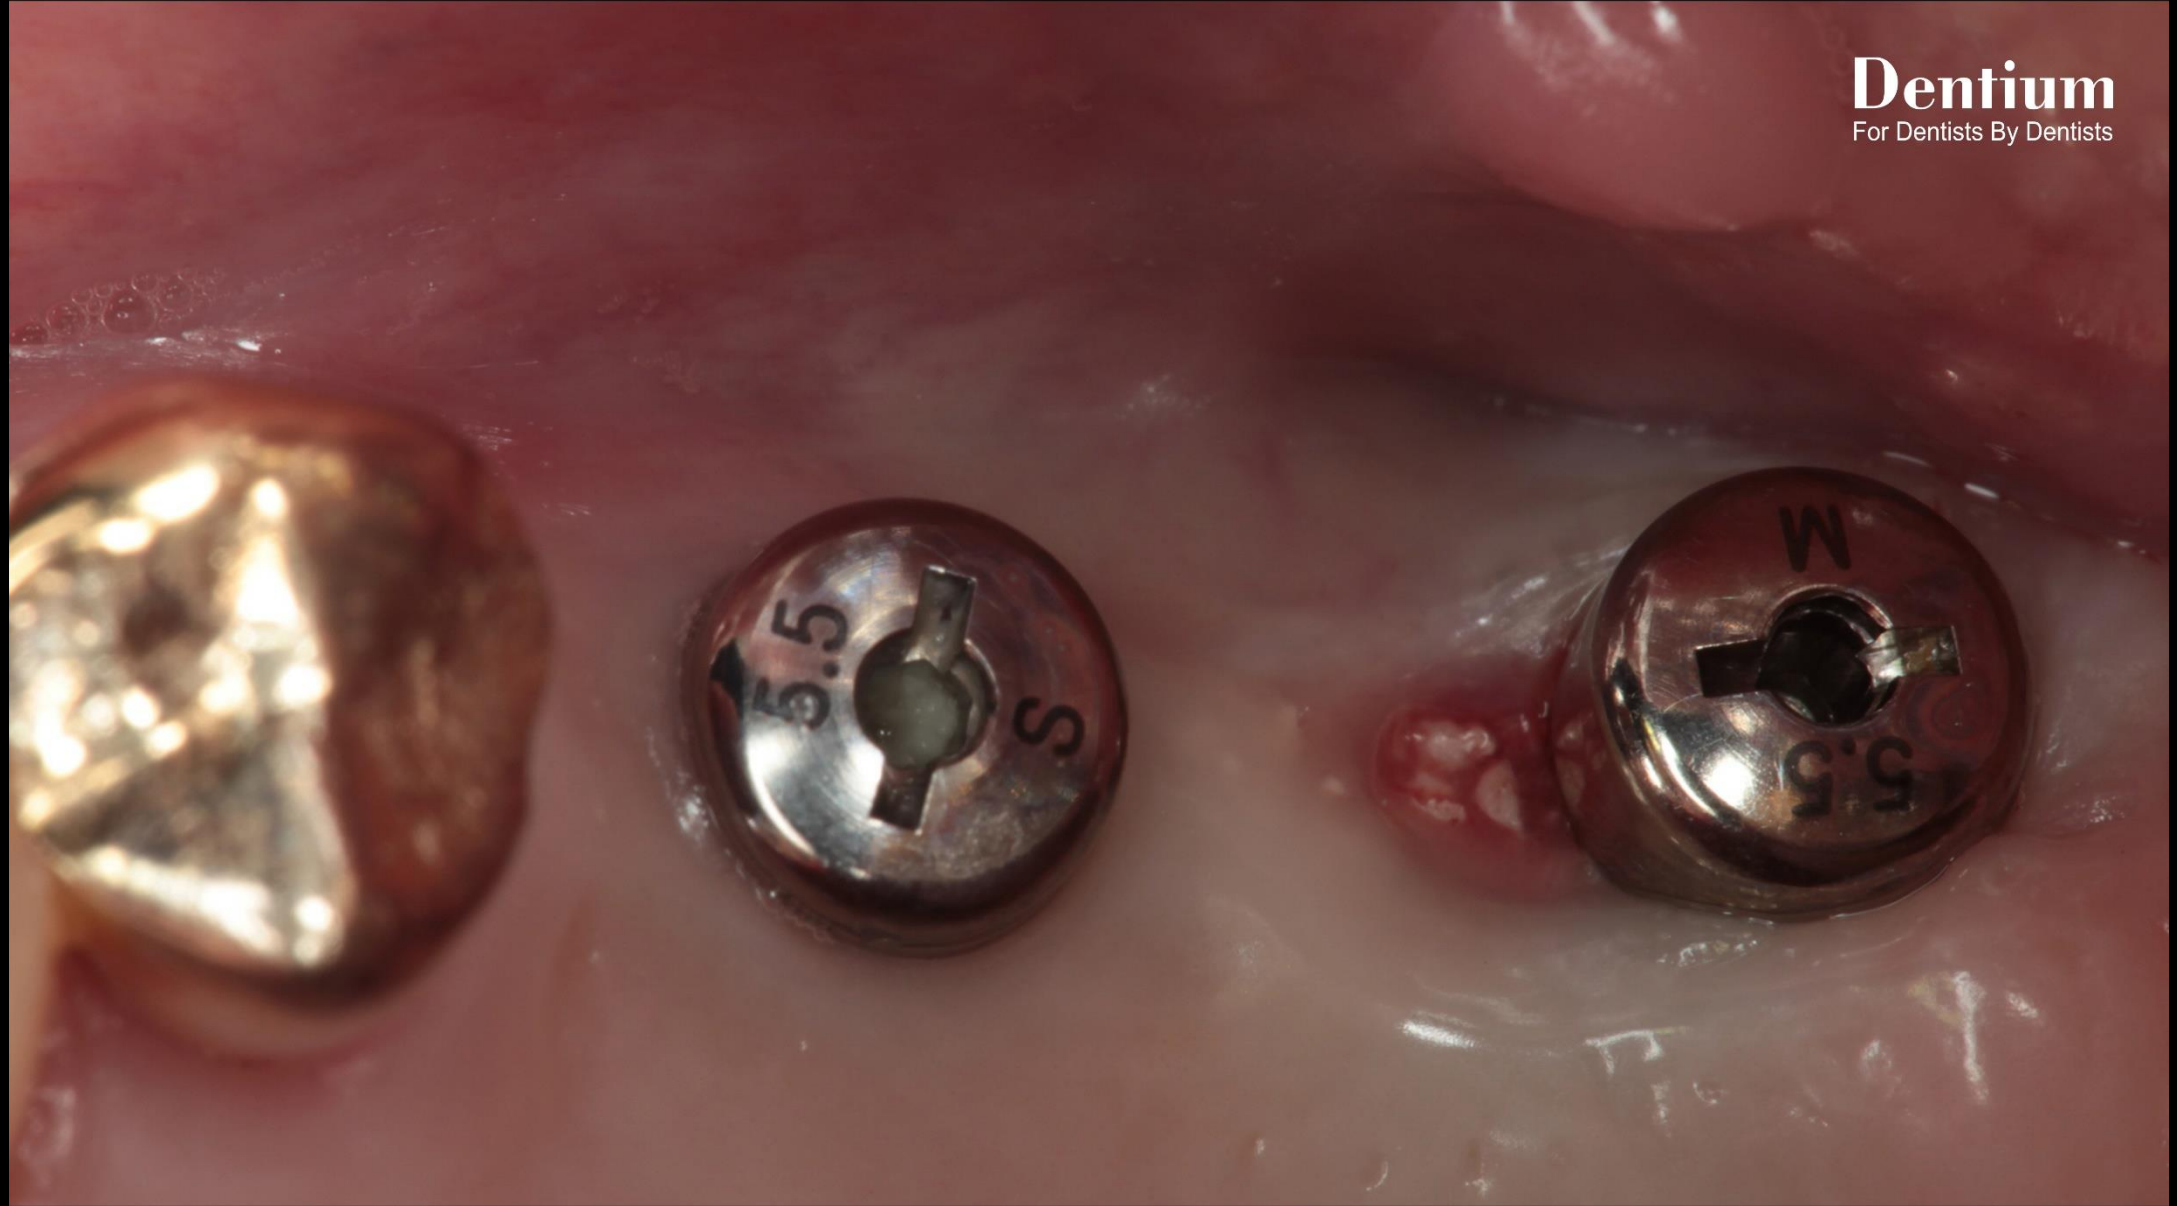
Healing : 2 months (Second stage surgery)

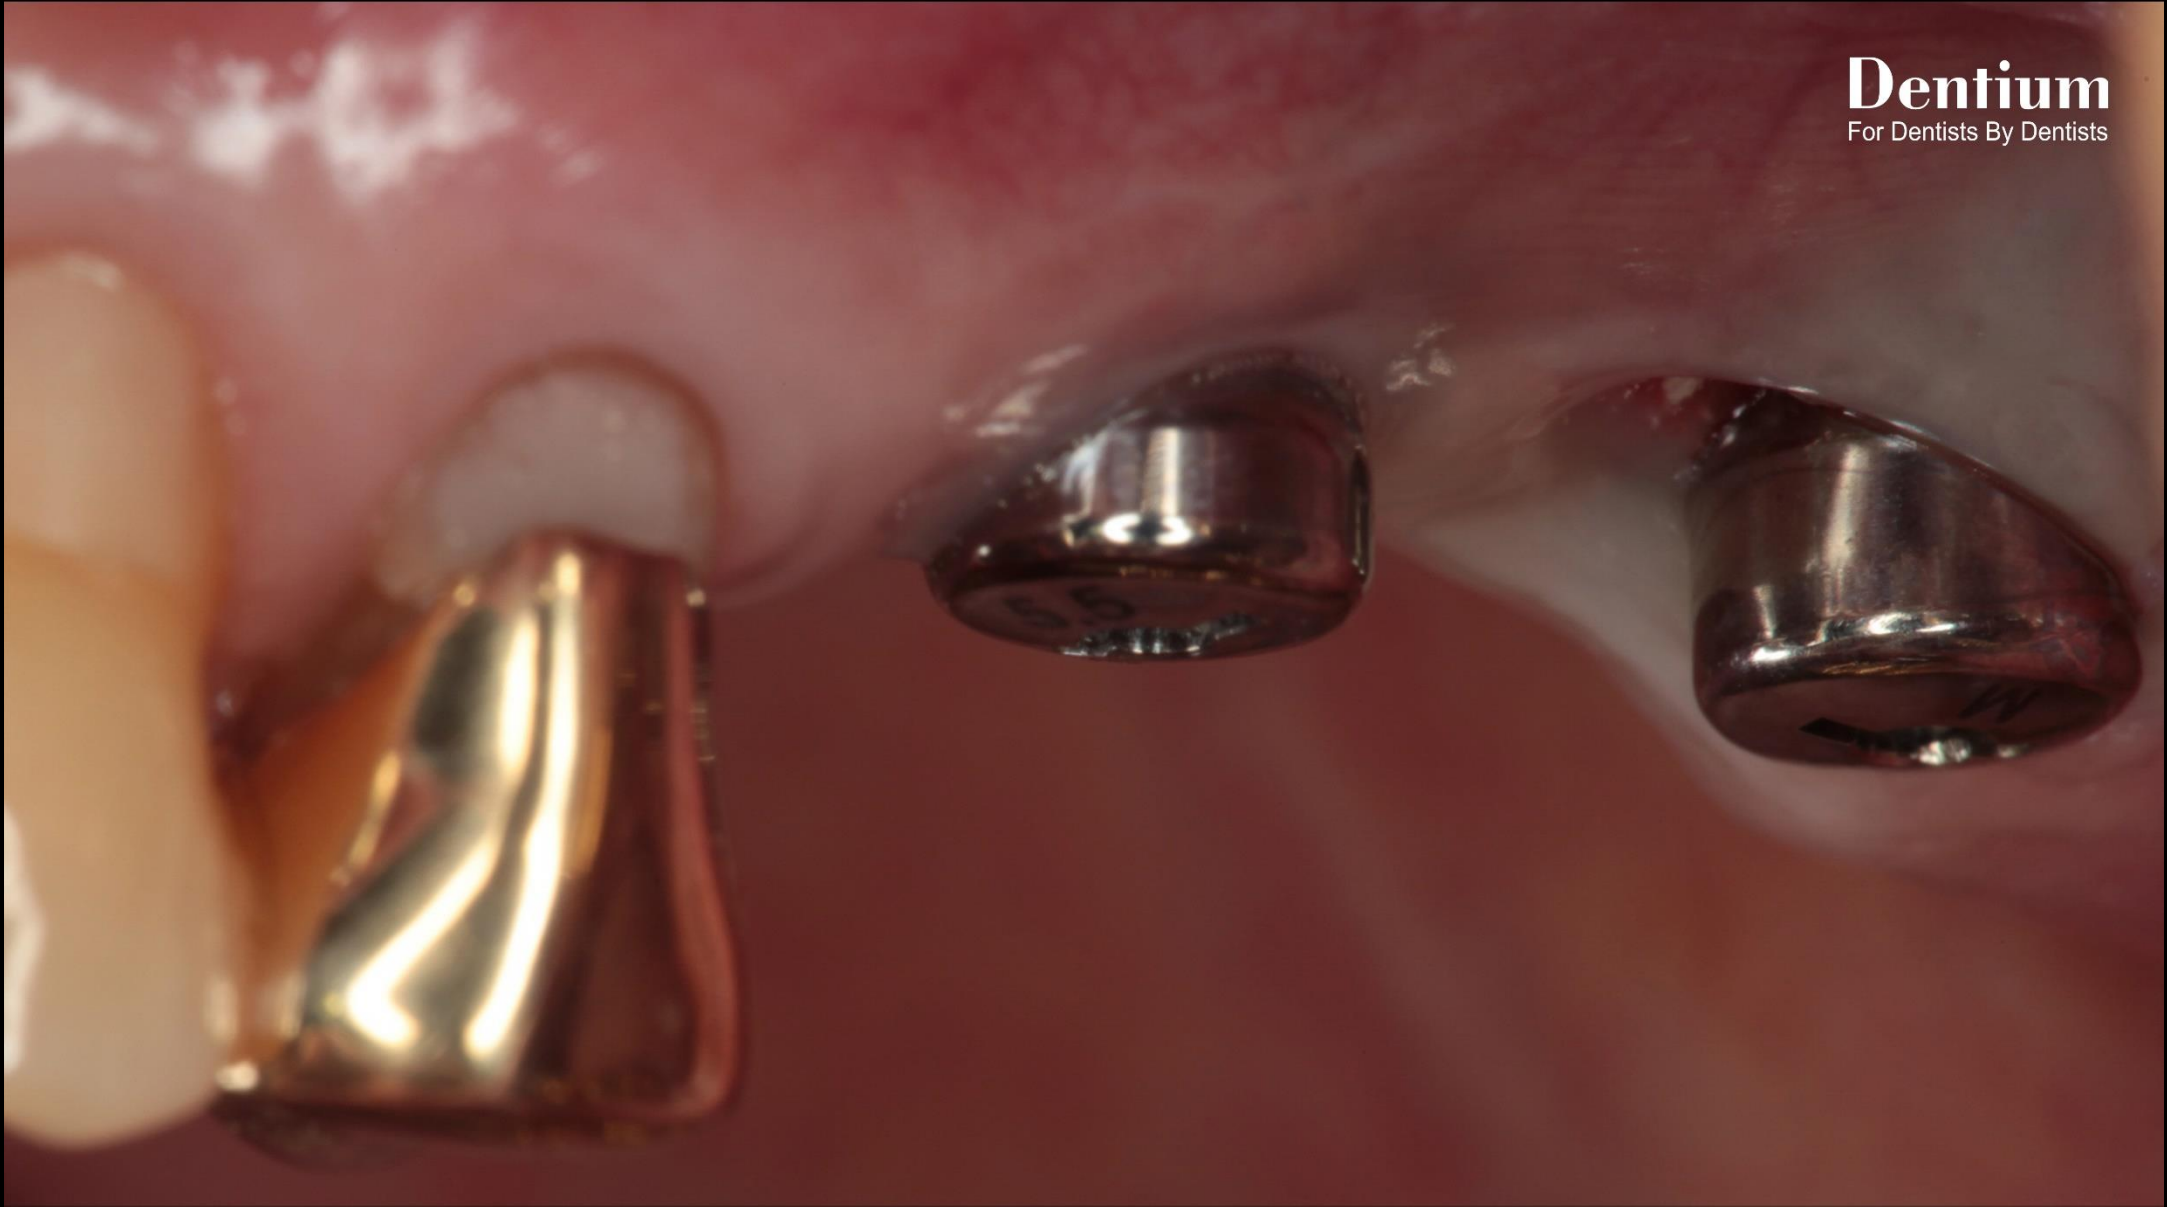
Healing : 2 months (Second stage surgery)
