Removal of malpositioned implant fixture on post.Maxilla

Dr.root
Well dental clinic

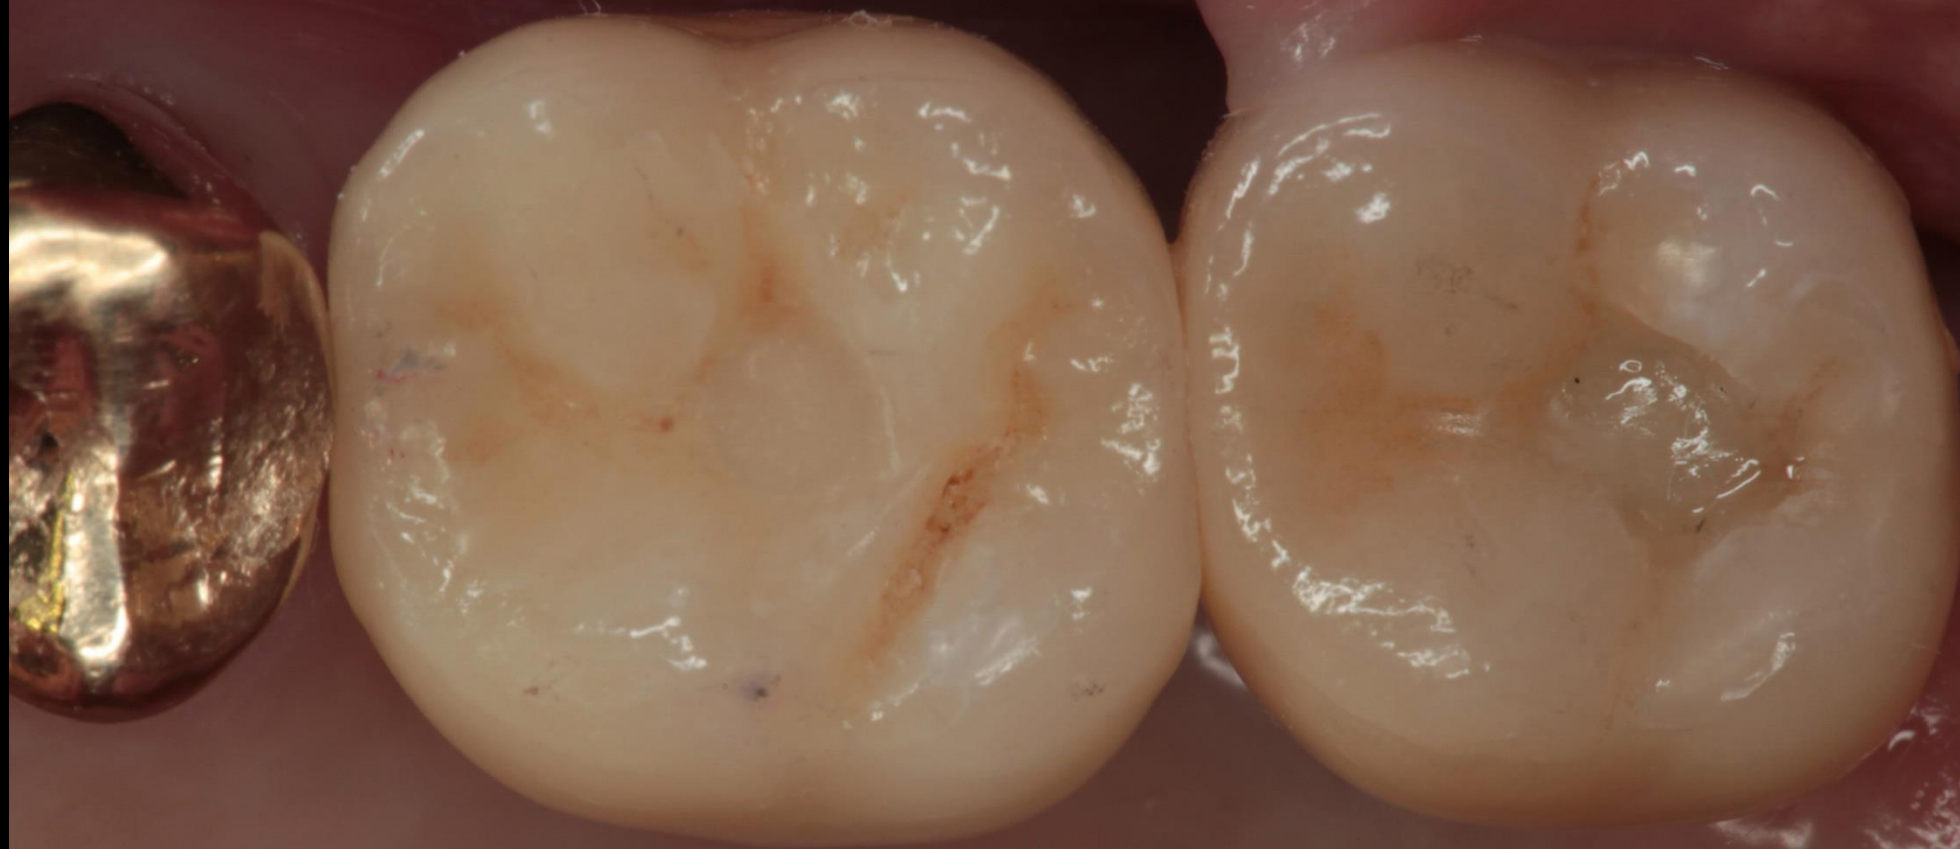
Final prosthesis

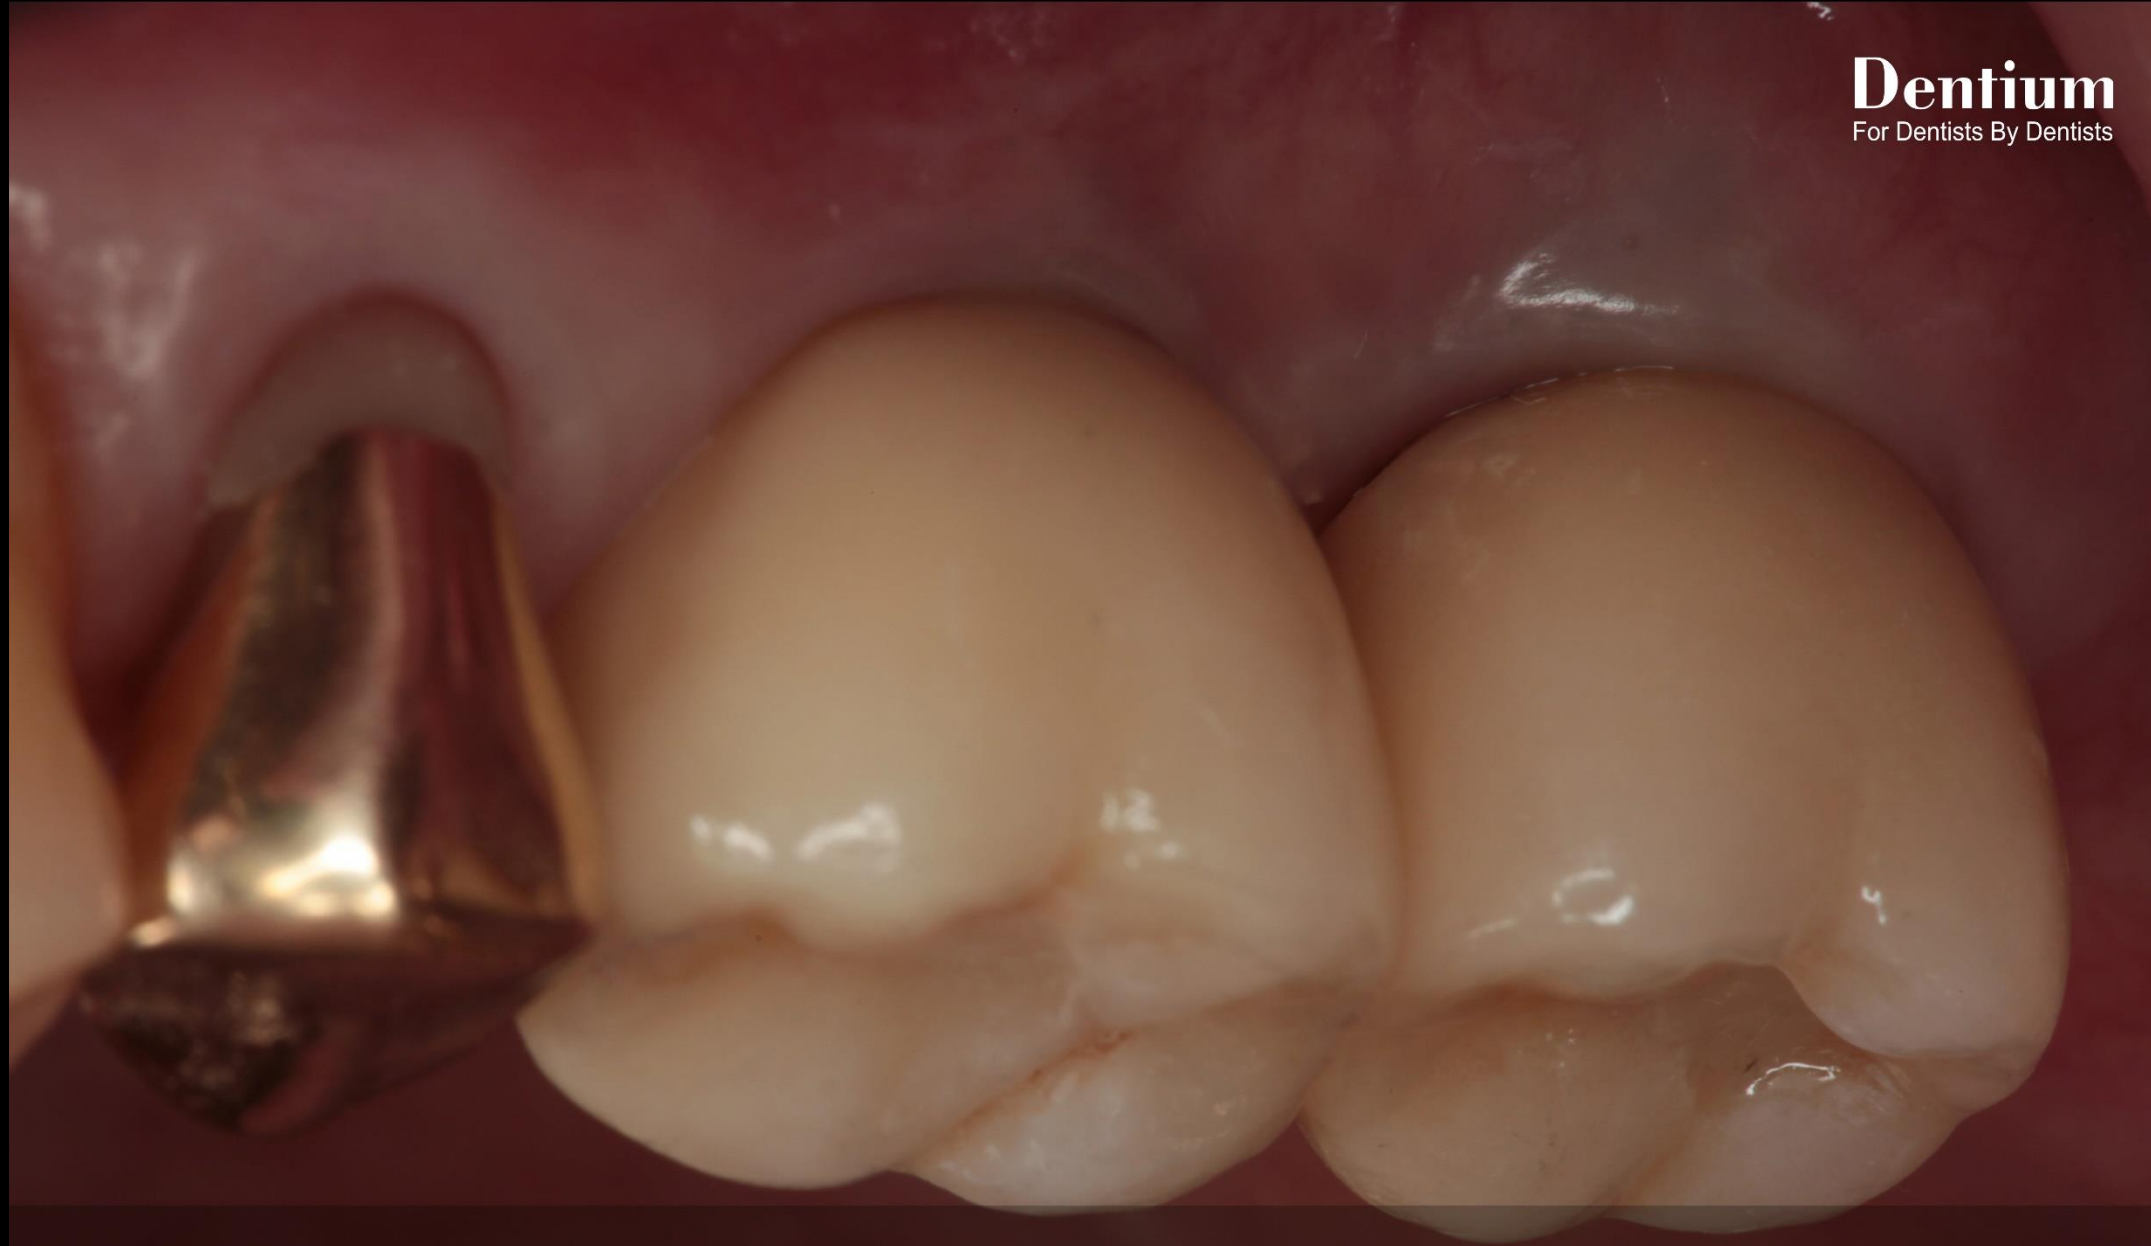
Final prosthesis

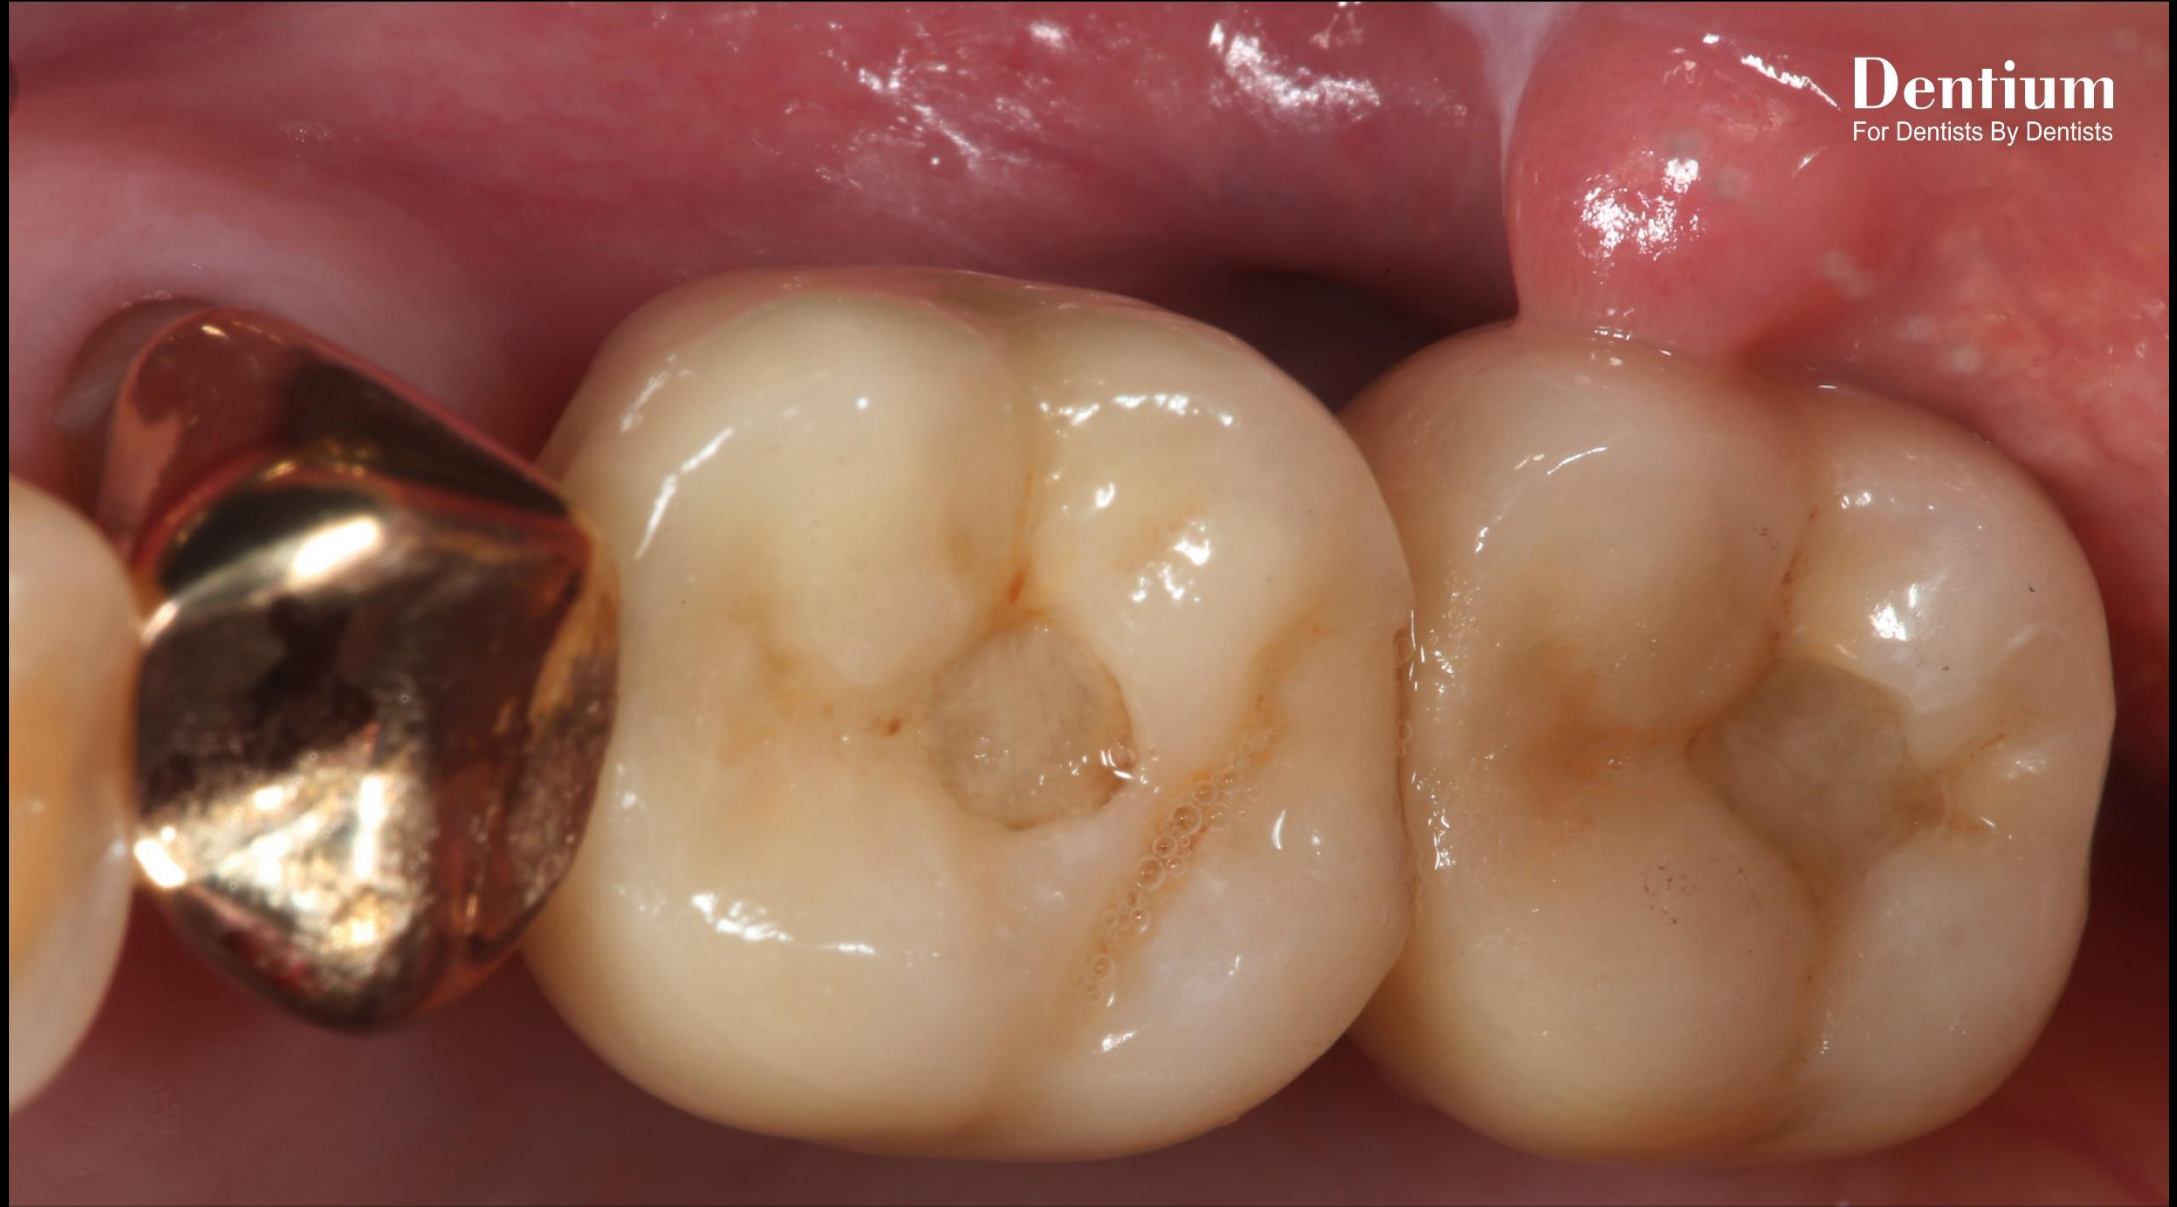
Follow up : 1 year 2 months

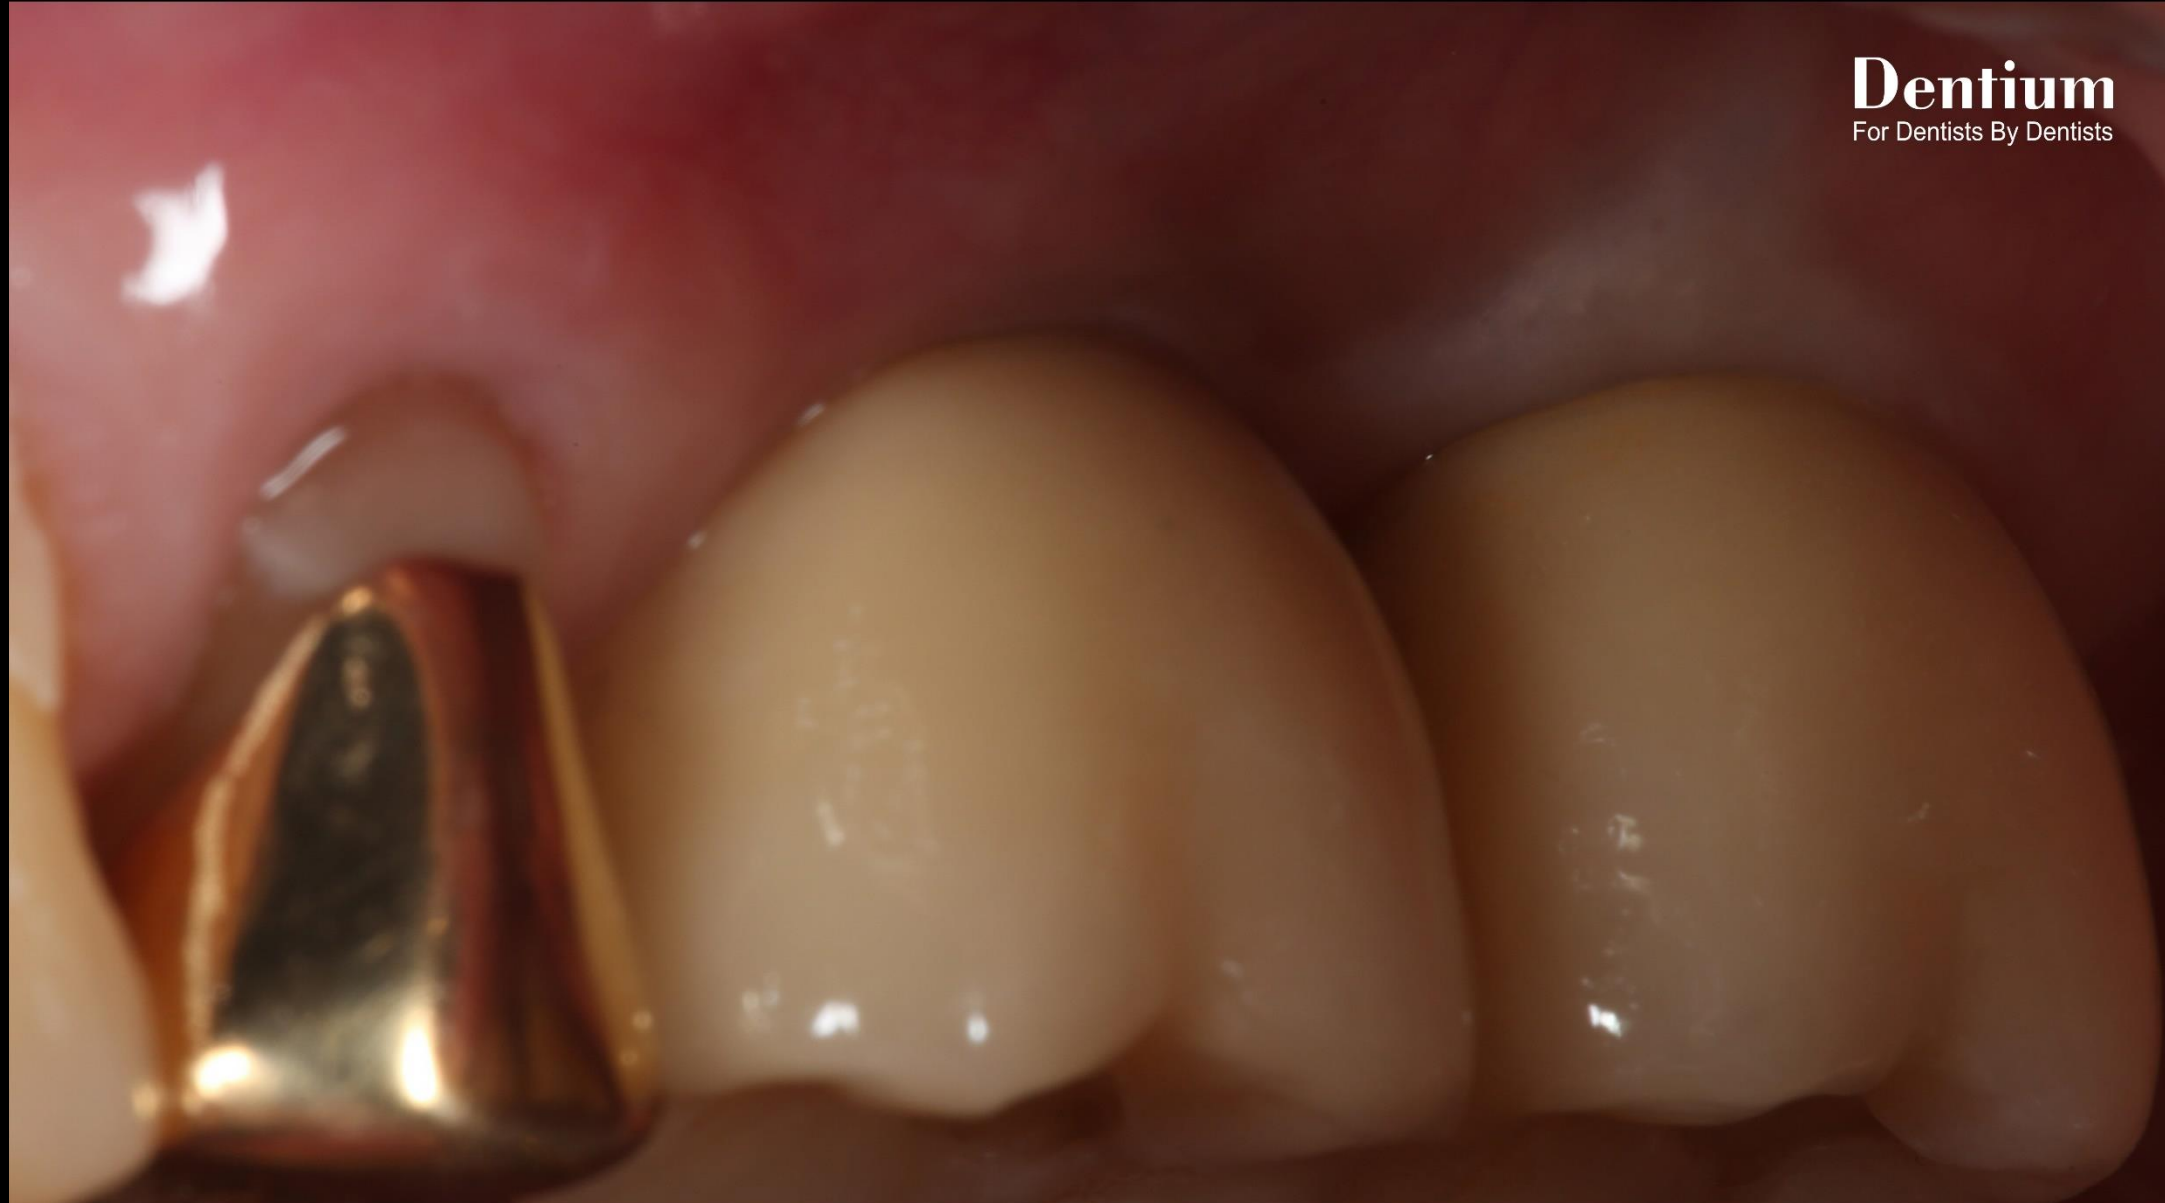
Follow up : 1 year 2 months
